Recent Developments in Chlor-Alkali Technology

Technology Developments & Growth Scenario in Chlor-Alkali Industry
(Global and Indian Perspective)

Organized by Indian Institute of Chemical Engineers
New Delhi

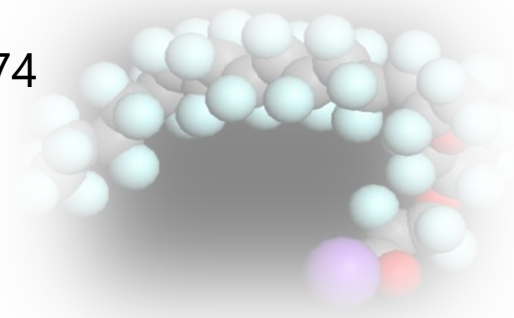
Double layered membrane

The effect of carboxylate ion-exchange site was found in 1974 contributing higher current efficiency

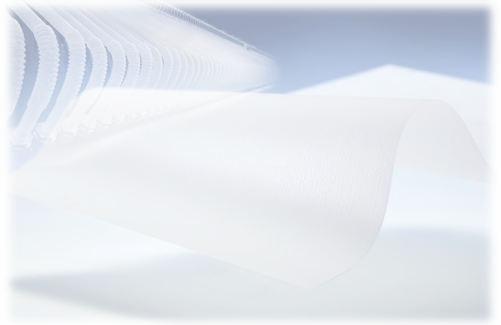
2018
3i-technology
AsahiKASEI

ion channel control, improved coating, improved structure contributed to low power consumption.

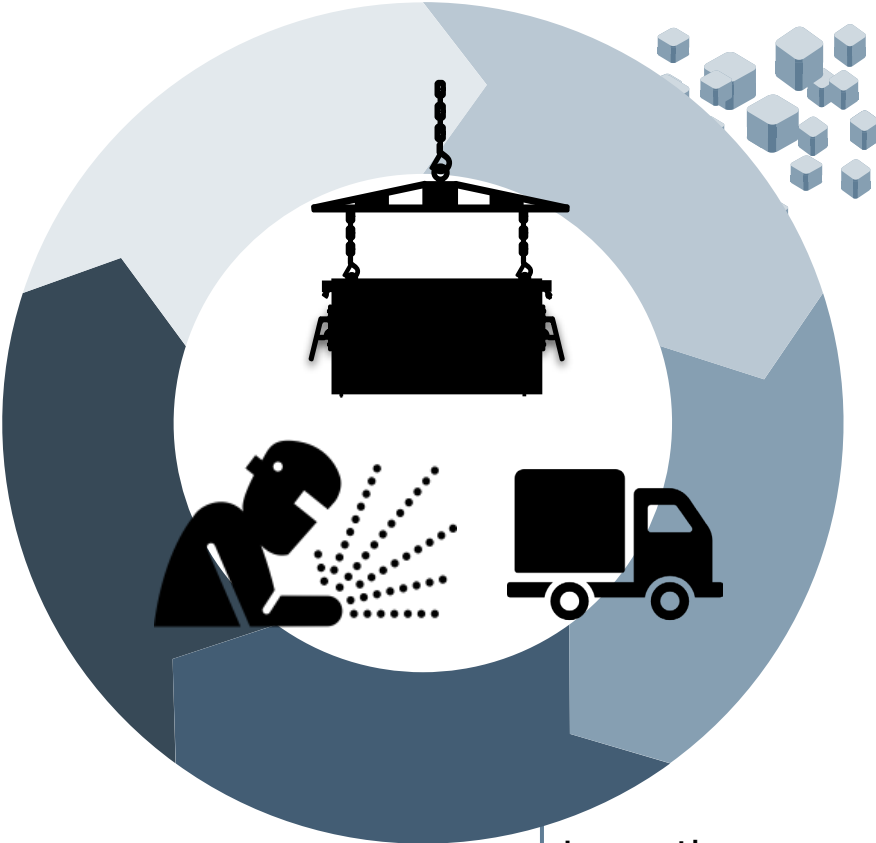
Today

Long time

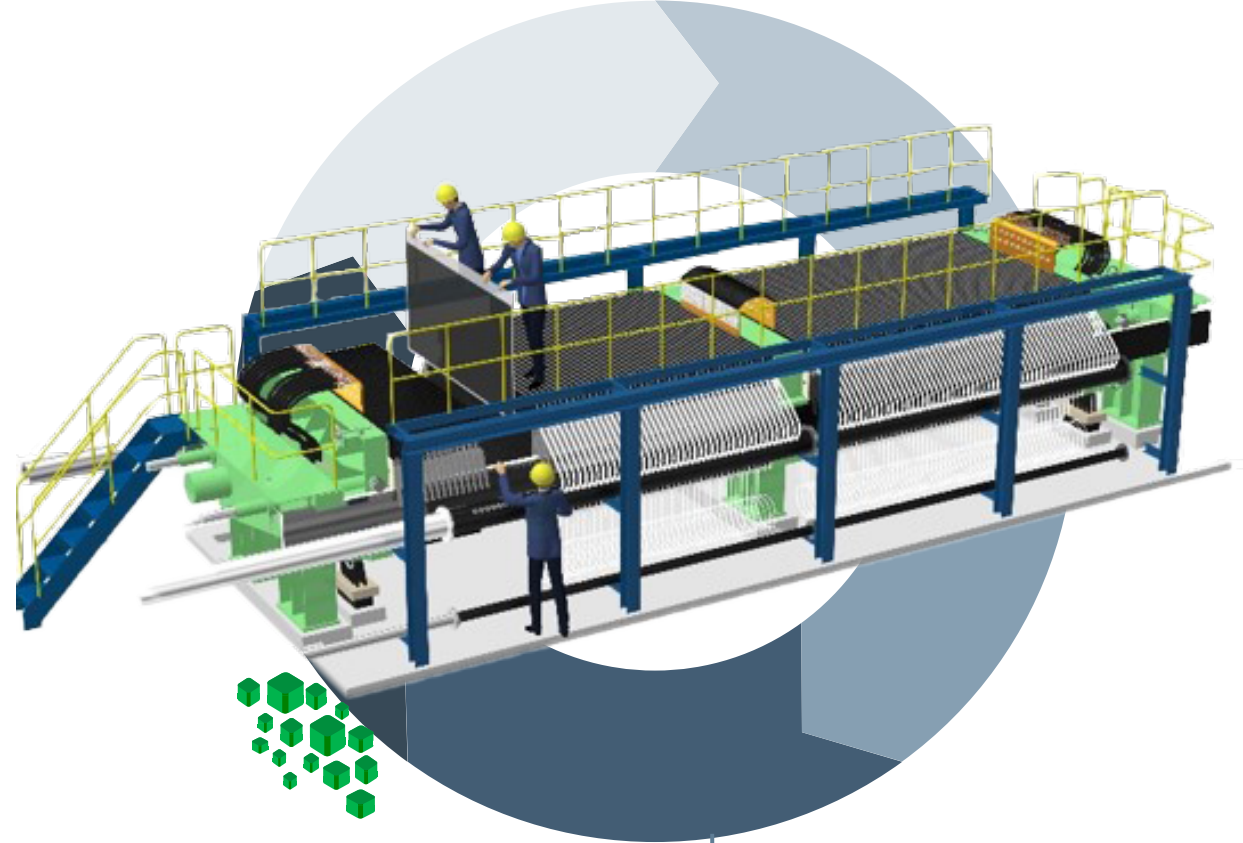
Future with Membrode™

Short period

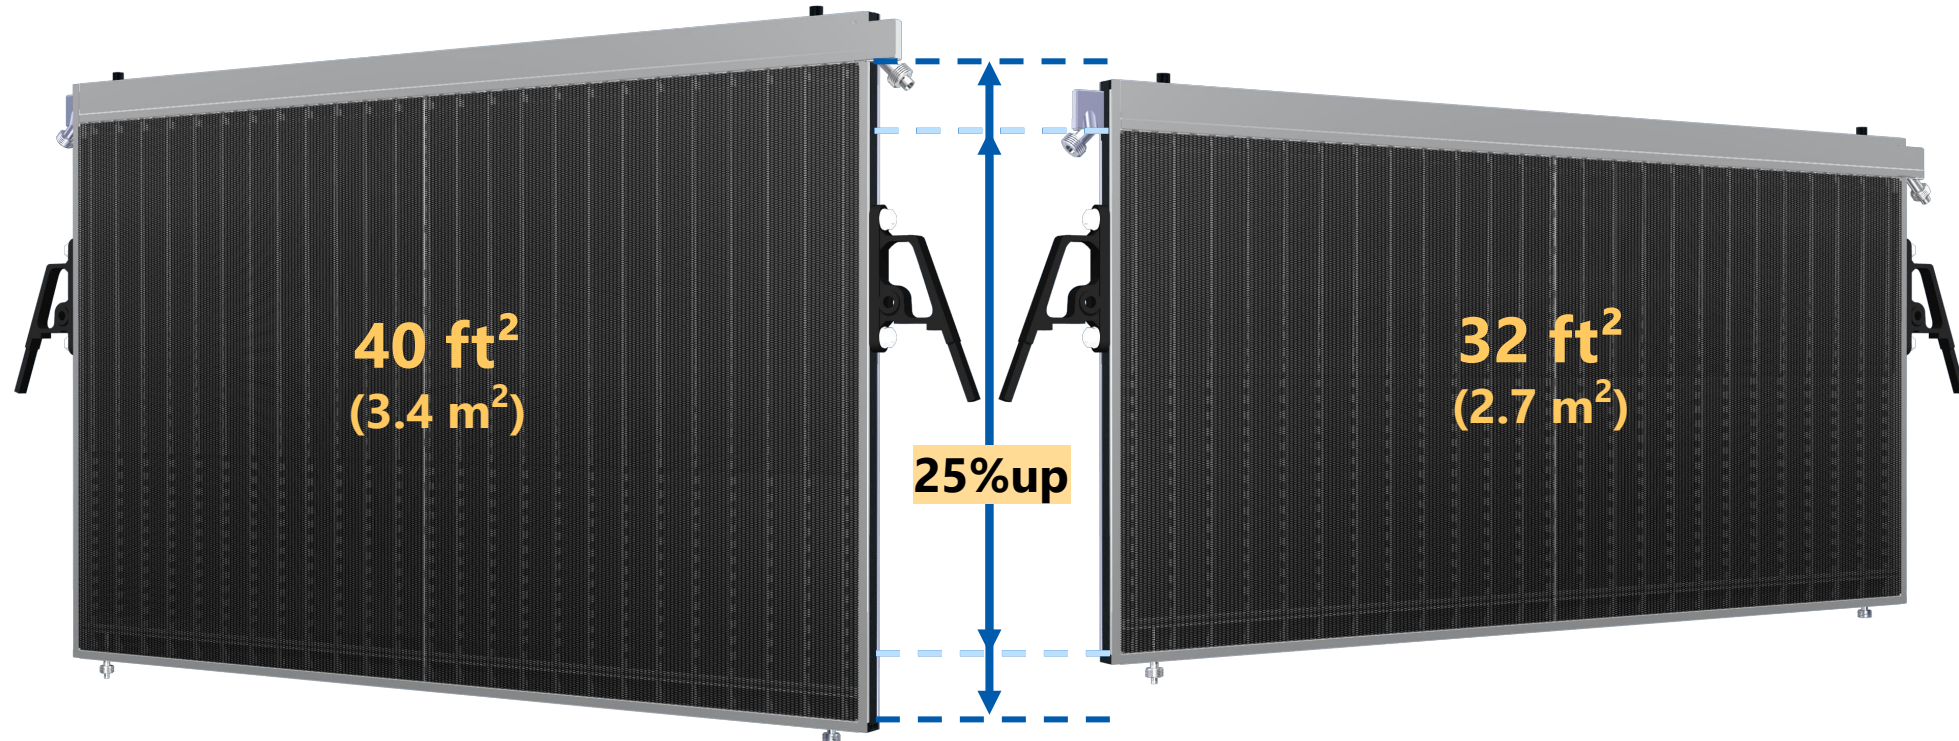
New Acilyzer™

New
NC40Z

Conventional
NC32Z

- ✓ Decrease current density while maintaining the same production level
- ✓ Increase production value while maintaining the same current density level

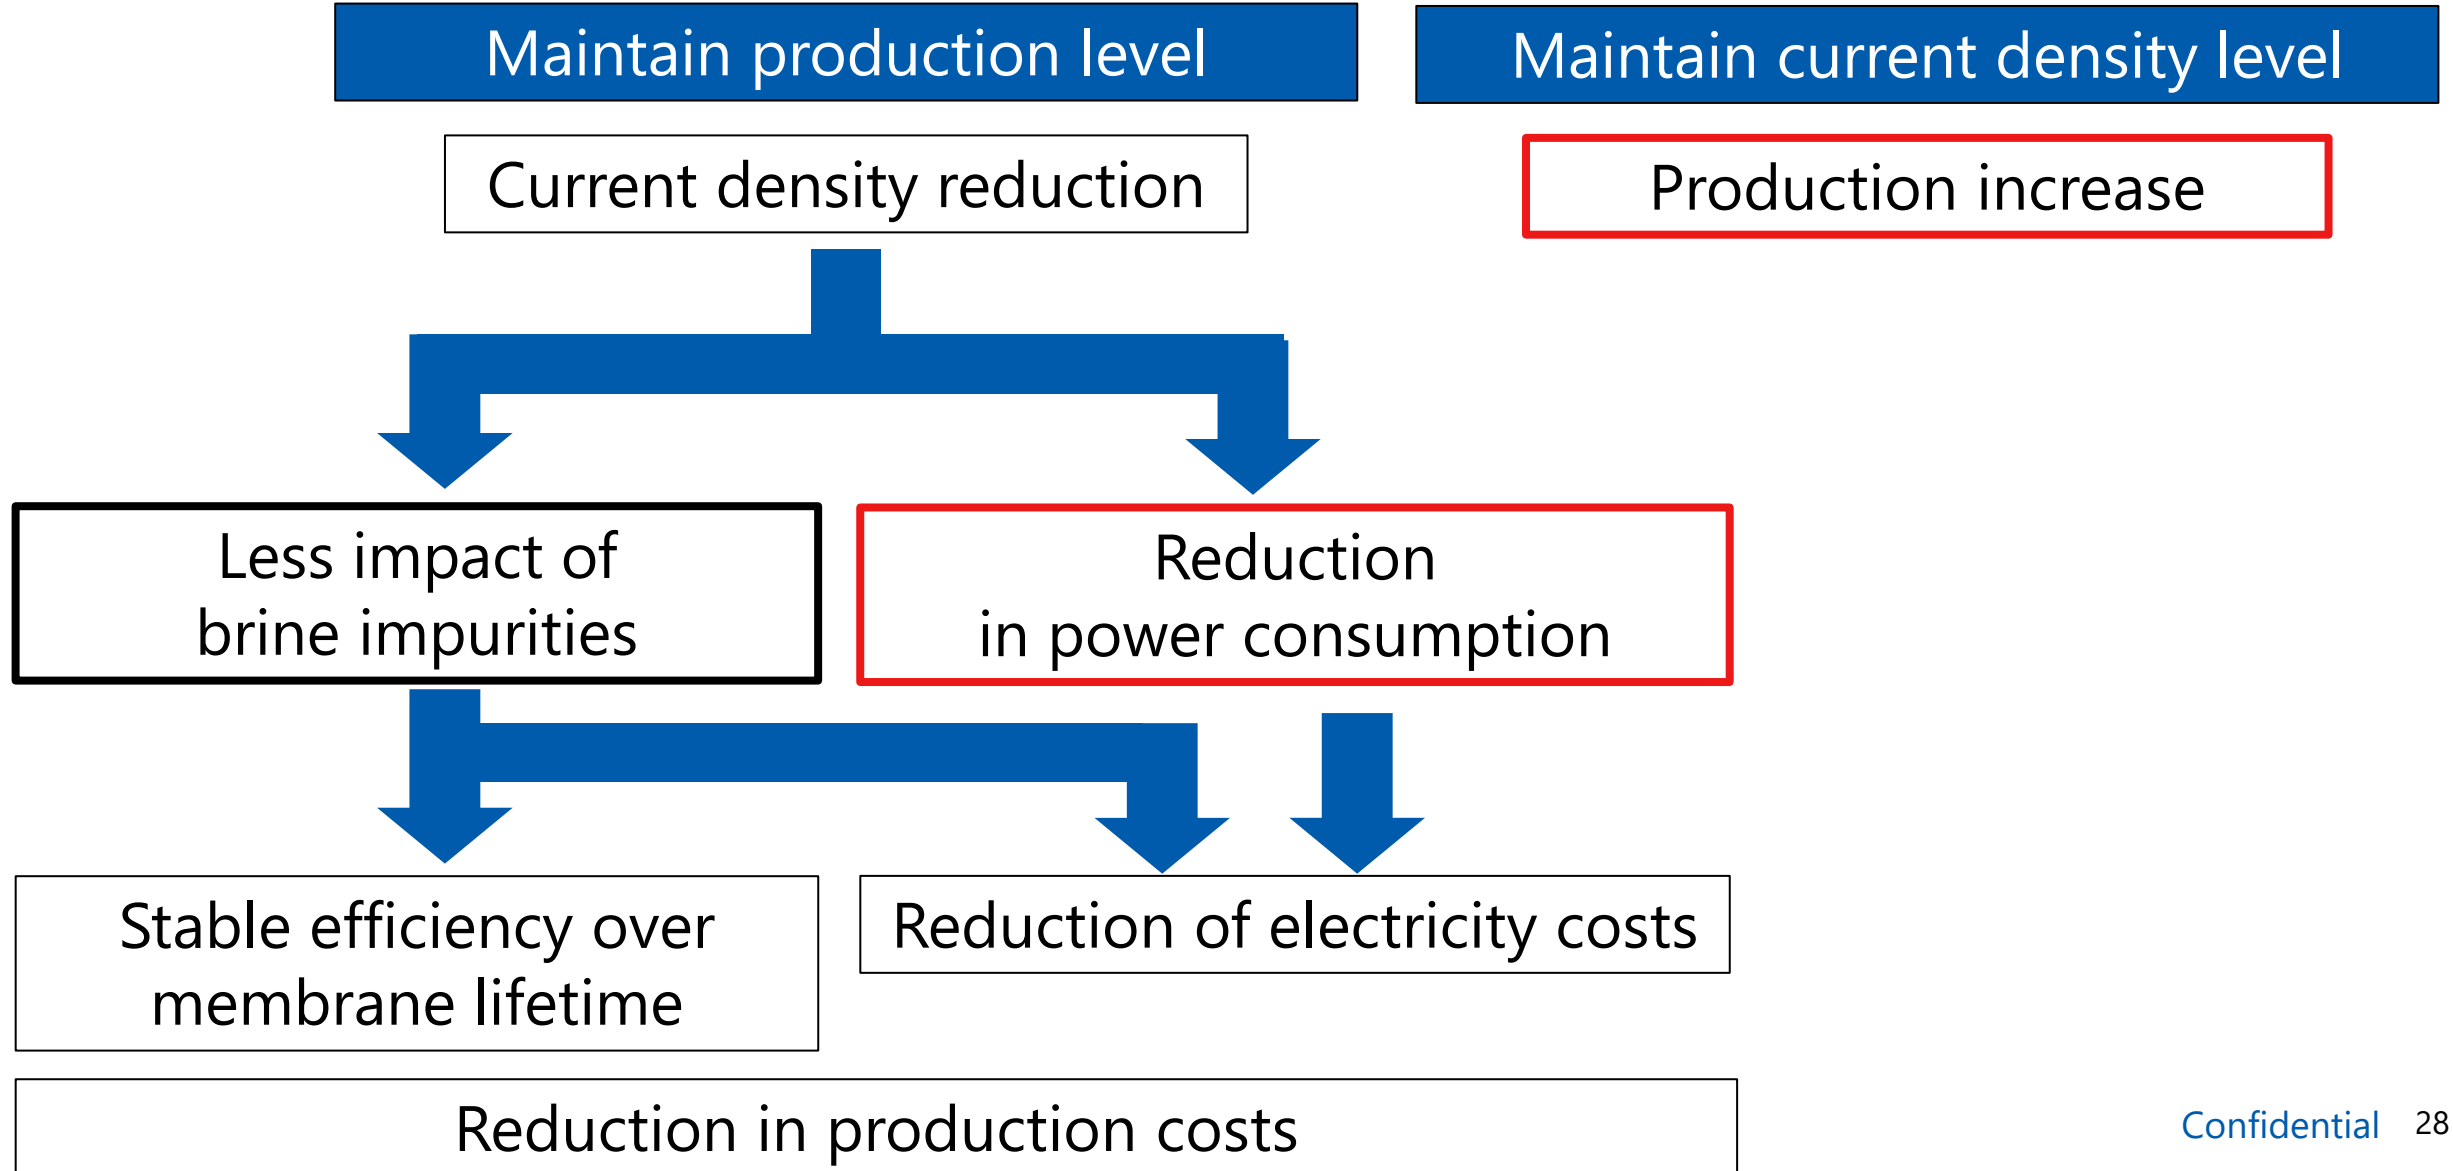
Benefit from New Acilyzer™ NC40Z (3.4m²)

- Case1 Maintain production volume; P·C reduction of approx. 70 kWh/t-NaOH
- Case2 Maintain current density; Production volume increase of approx. 25%

P·C reduction of 70 (kWh/t-NaOH)
or 25% increase of production volume

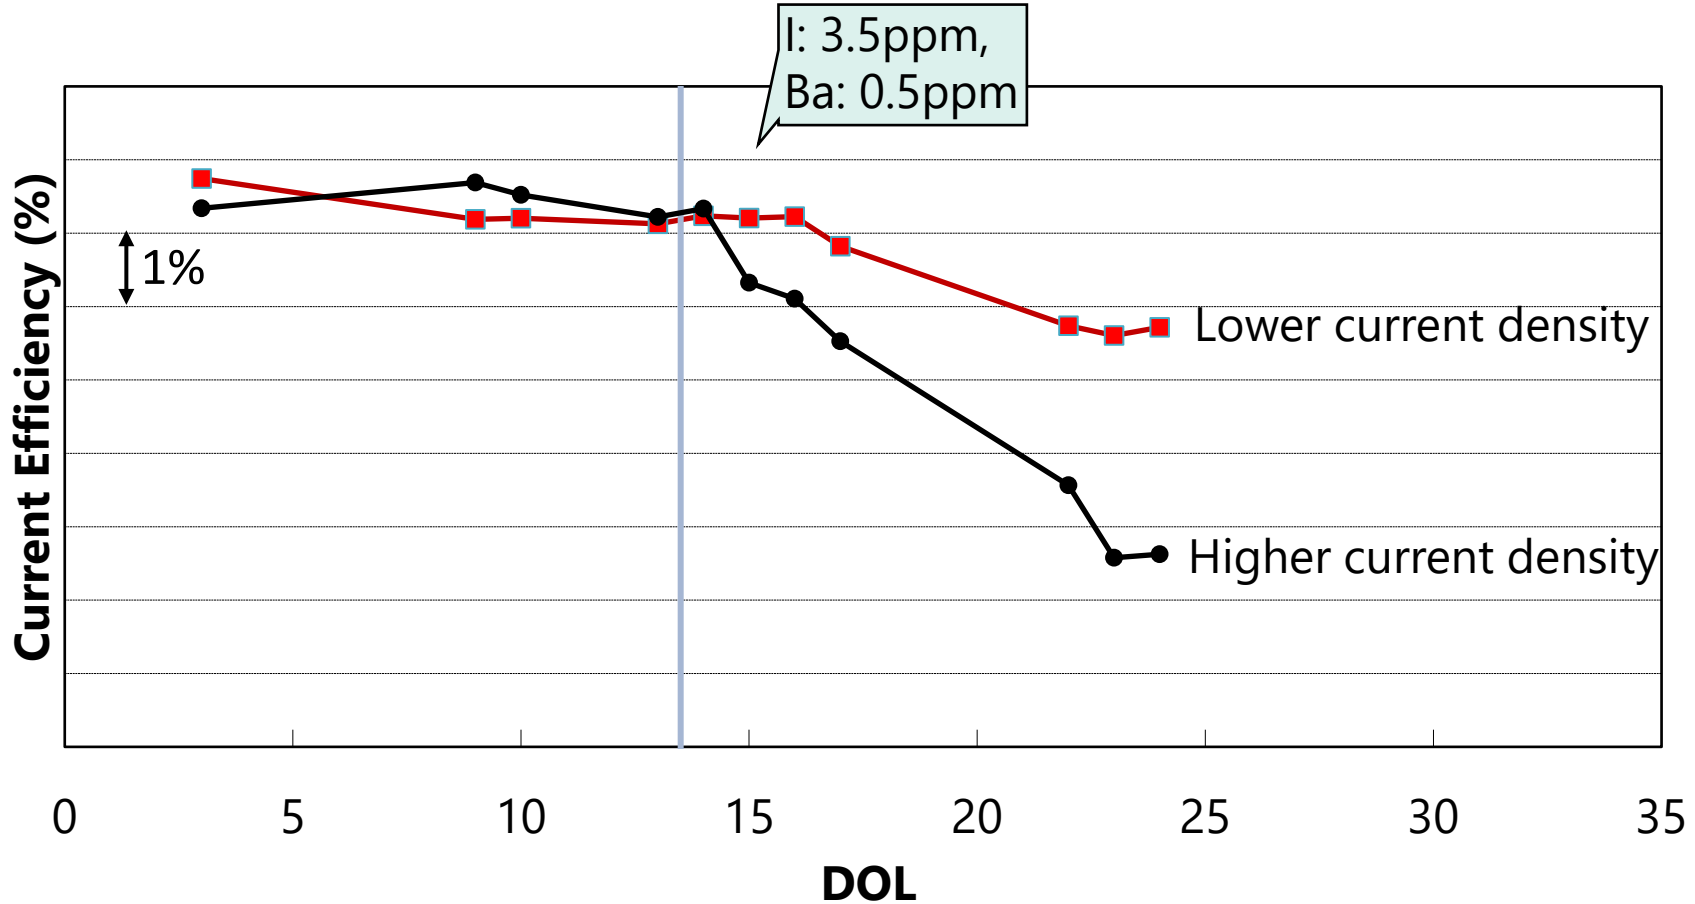
Prevention of CE decline with lowering C.D.

Improved CE stability against impurities with lower current density

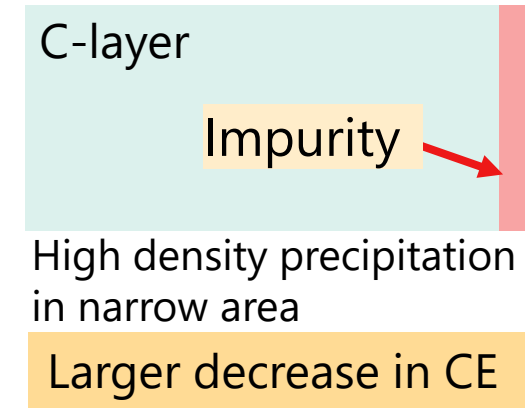
High current density

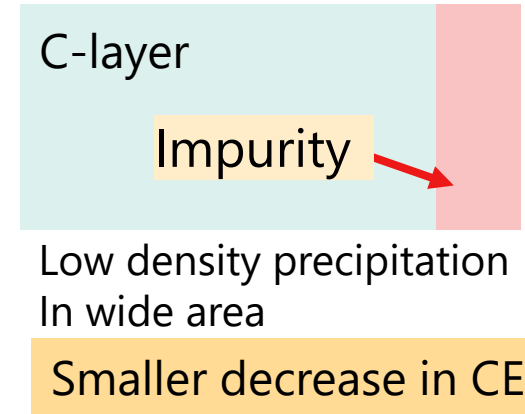
Low current density

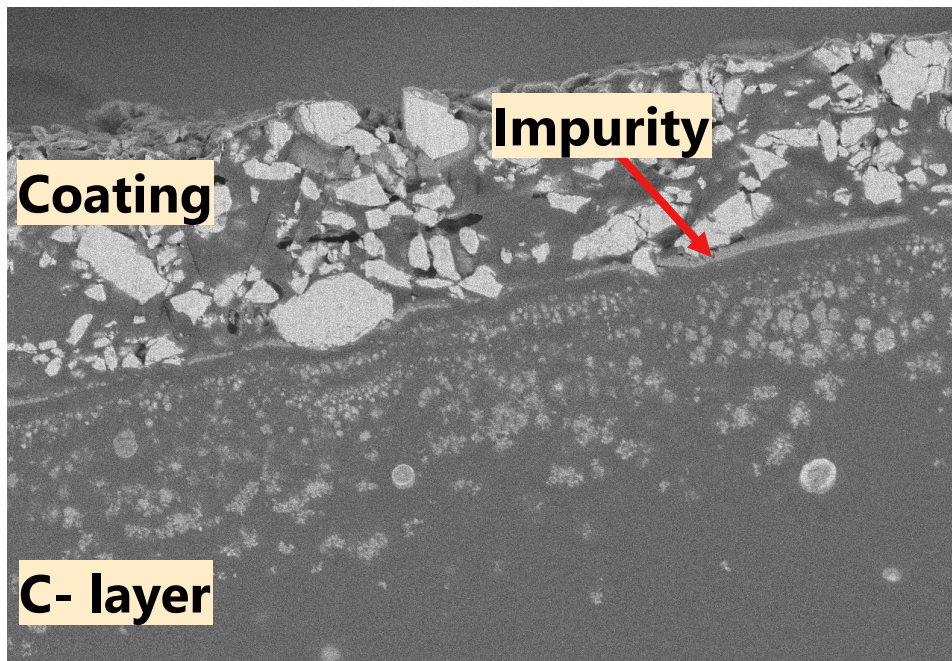
High density accumulation of impurity at film/coating interface

It is possible to reduce membrane degradation by impurities with keeping production volume by NC40Z

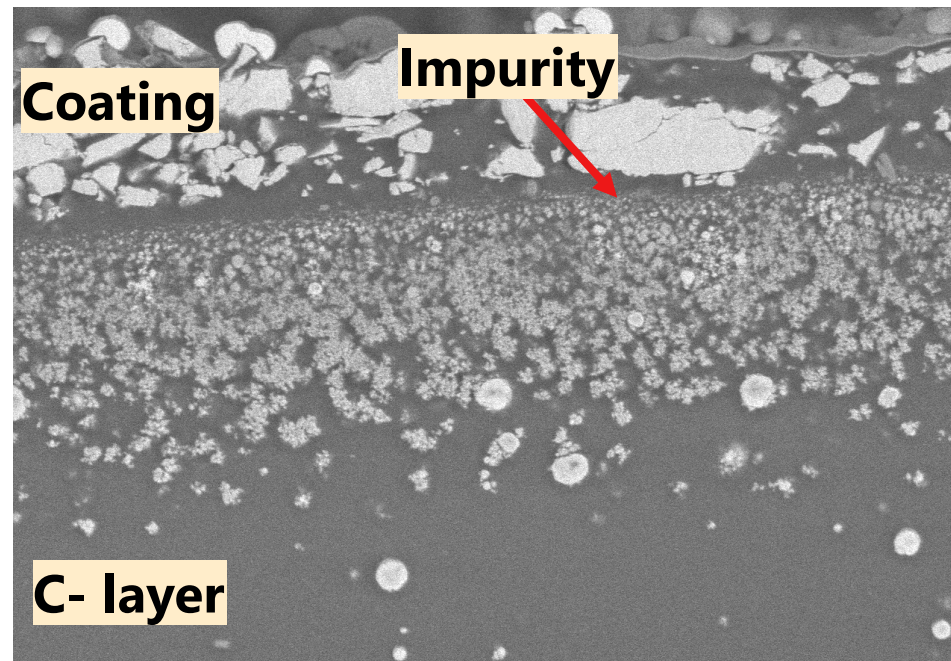
Lower density accumulation of Impurity at wide range
